**New Durham Meeting House**  
New Durham, New Hampshire

**Historic Building Assessment**  
*with*  
**Preservation Guidelines**

**February 2009**

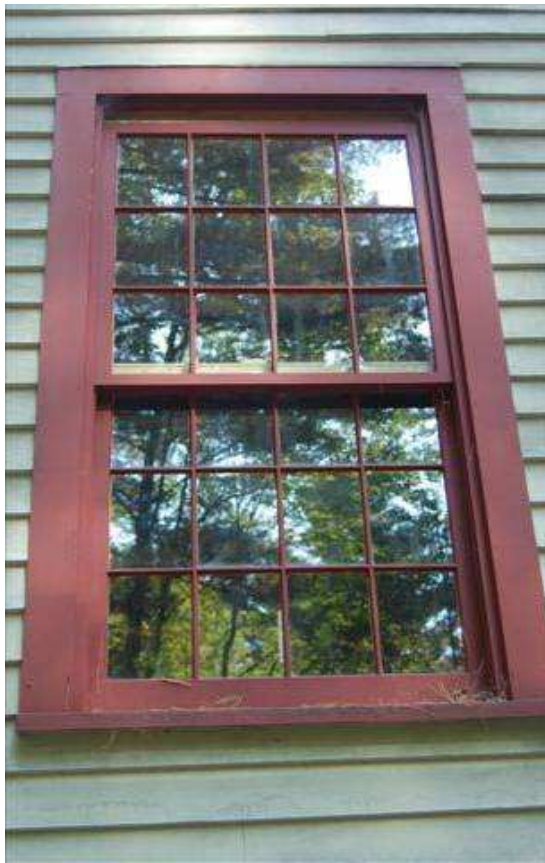
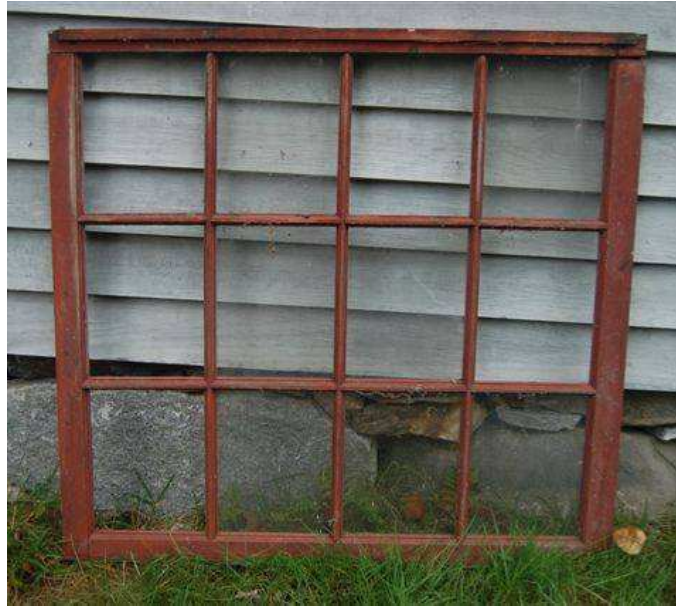
All of the window frames and sash date from the late 1980s. The sash are double hung, 12/12, with 7" x 9" glass. The opening for the window frame is slightly smaller than that which appears in the late 19<sup>th</sup> photographs. (The photographs also show the original windows had somewhat wider trim boards that abutted the eaves of the building.) A single, early, twelve-light sash survives in the building. Its muntin profile is more akin to a 1792 date than 1770, suggesting at least some window sash was replaced when the building underwent major work in 1792. Since the late 19<sup>th</sup> century photographs also depict 12/12 sash, it is likely the 1792 sash was retained

when the building was cut down. This one surviving sash would serve as a useful prototype should the existing windows ever need to be replaced again.

*At left: detail of a replacement window. At right: sole surviving historic sash, likely from the 1791-92 era*

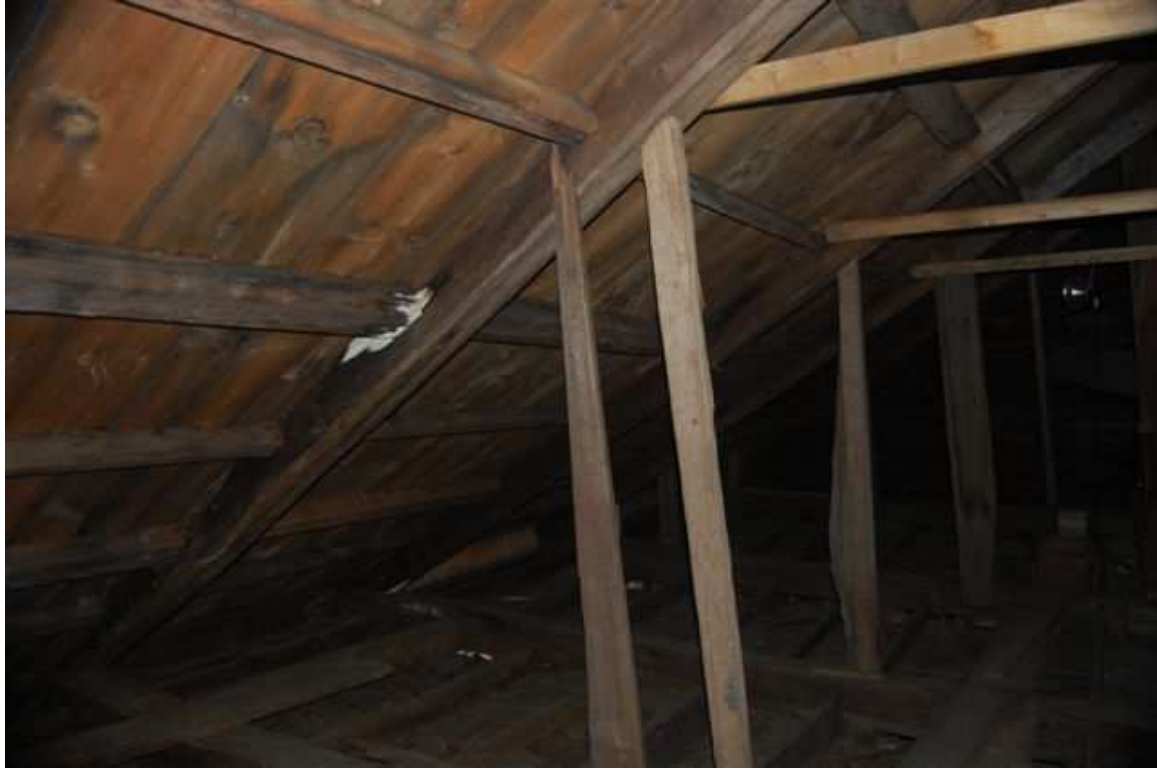
*Roof framing system, showing original (1769) hewn rafters and purlins. The white patch shows an area that had gotten wet and may need to be repaired (or replaced with like material if it is not salvageable). The left vertical brace is one that was added to keep the collar tie from sagging. The sheathing boards seen in this photograph are replacements.*

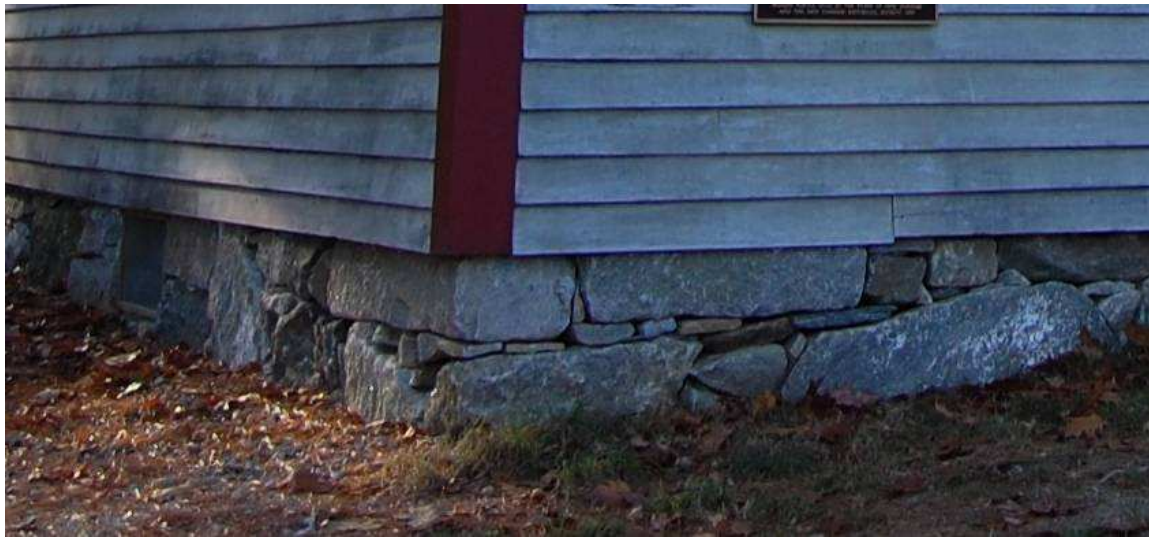
The existing foundation (unmortarted granite blocks and stones) rests on a combination of ledge and soil. There are also areas of crushed stone, which were added in 2006 to improve drainage. Building elevation measurements taken around the building over the last two years suggest that the foundation is reasonably stable.

In 2006, the town contracted with JR Graton and Kevin Fife to repair the stone foundation. They removed a portion of the original stone work and replaced it with early 19<sup>th</sup> century split stones. Photographic documentation from that time indicates that the building was “held in place” and stones were removed and then replaced in areas that had shifted or otherwise changed. Some crushed stone was added to allow for drainage.

*The east corner of the Meeting House showing the post-2006 foundation.*

Because the siding, trim and windows had been replaced in the 1980s (and made plumb and level), a full jacking of the structure was not carried out, as those sections would have to be “released and/or removed” first. While the good-faith effort to stabilize the foundation in 2006 was successful, the jacking of the building will still need to be addressed so that the posts/plates/rafters can be at the appropriate elevations.

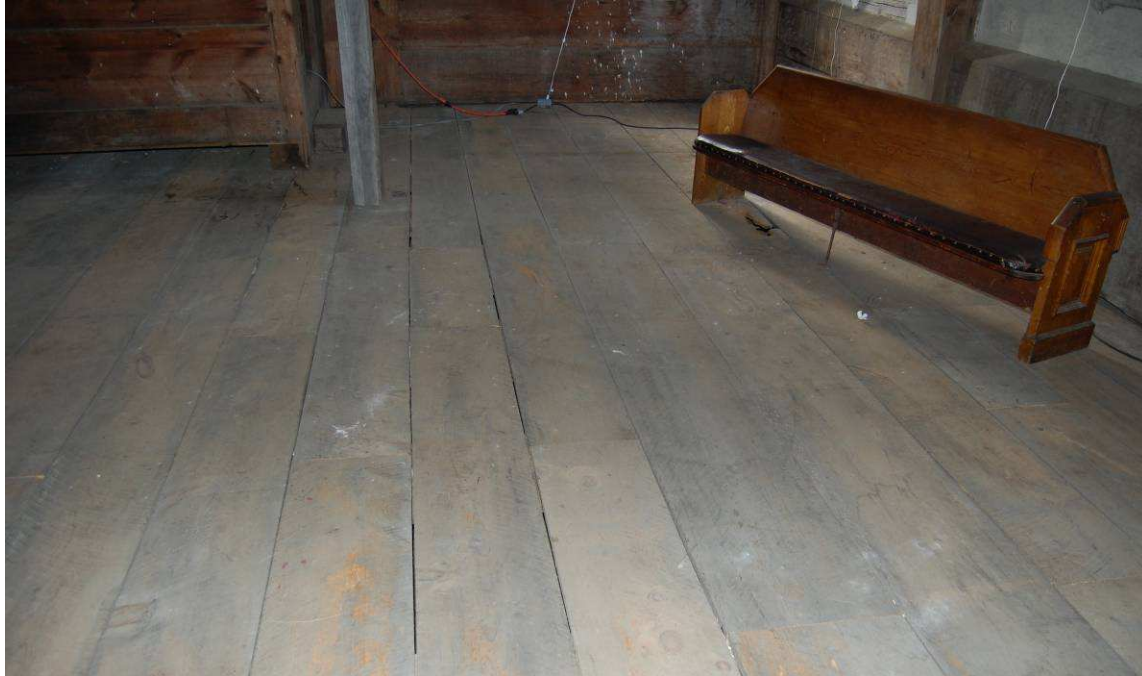
*Sills and floor joists:* The sills and floor joists have been repaired and/or replaced over the years. The only original members still in use may be select portions of the sill. A new sub-floor was installed during the 1987-1990 renovation. When the building was cut down, it was probably

*Existing floor finish dating from ca. 1990*

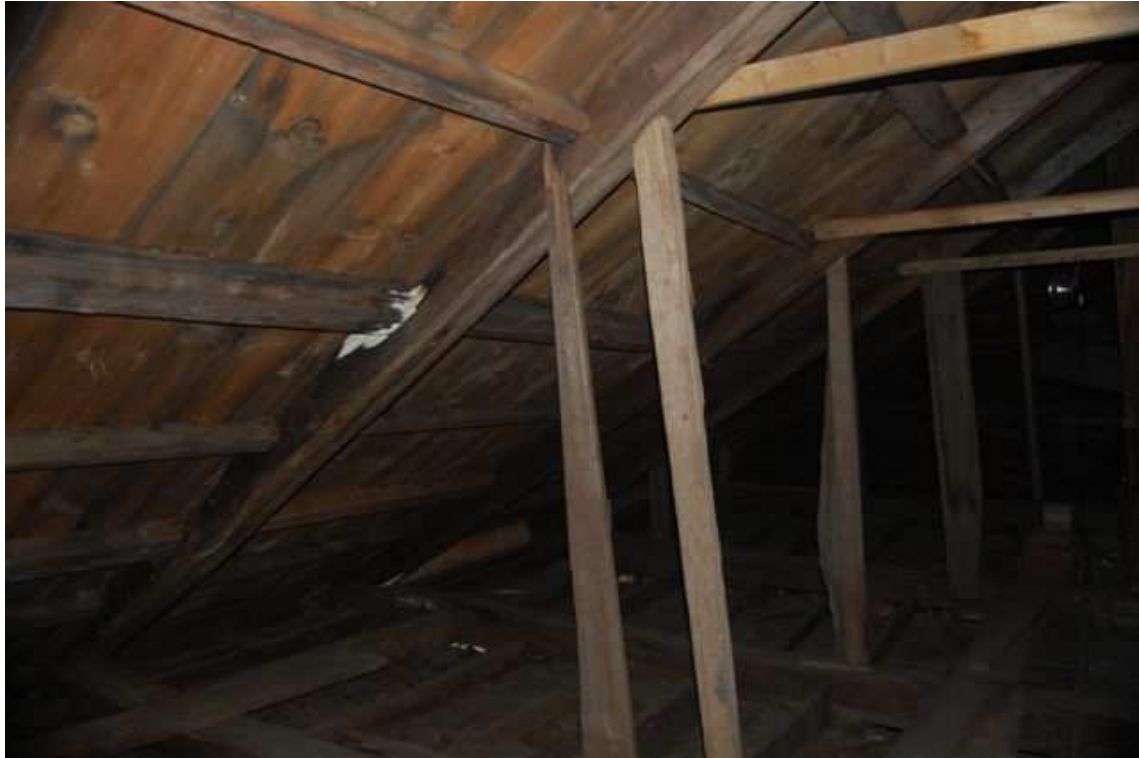
*Attic roof system and bracing, with later additional bracing.*

Originally, the braces going from the top of the collar tie to the rafters did not need to be pegged since they were always under compression and could therefore not fall out. However, once the wind braces were removed from the middle bents (as described earlier) and the ceiling joists were added and plastered, the roof truss system lost part of its support. Therefore, while the original brace did not require a pegged connection where the collar tie meets the rafter (particularly near the middle of the truss), the altered configuration should have had a pegged connection. The sagging of the collar ties from the weight of the additional ceiling joists, boards, lath and plaster, as well as the removal of the wind braces between the collar ties and posts, have caused the other braces to drop out and new, longer braces were needed.

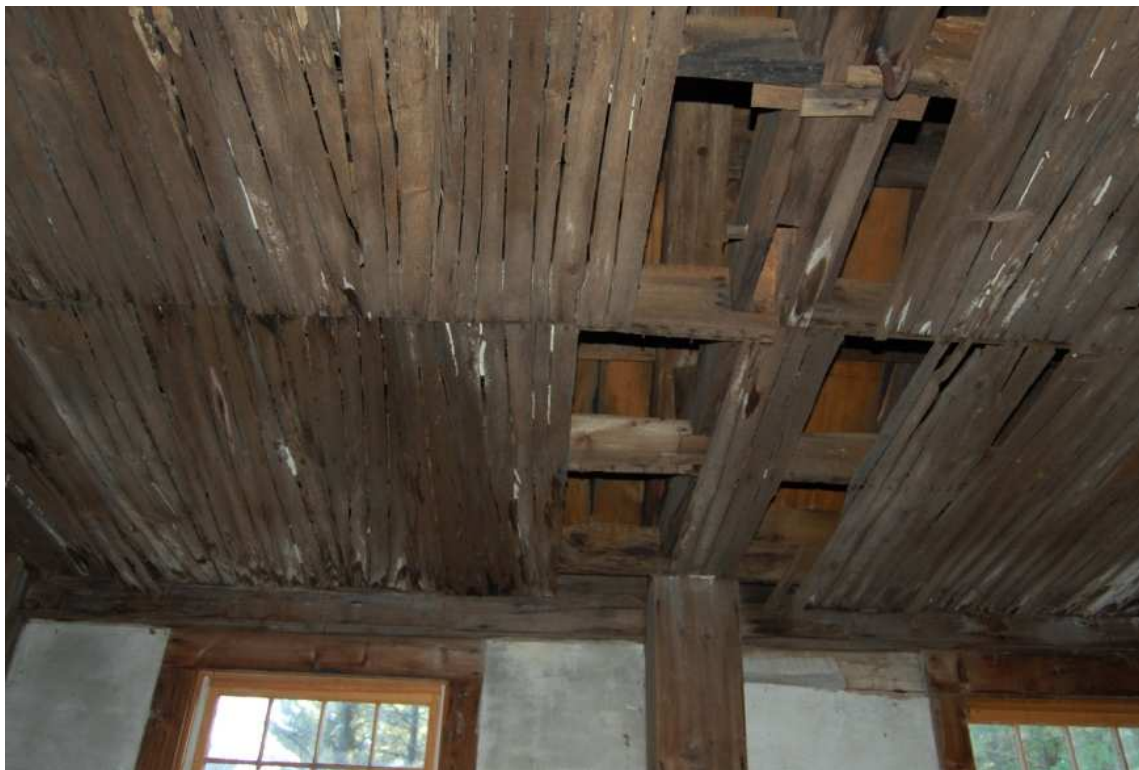
<sup>1</sup> The missing plaster is due to structural failure. When the building was cut down in 1838, the town removed the wind braces, in order to acquire better head room. However, in so doing, they undermined the roof system. Years of snow load pressure on the rafters, coupled with the weight of the ceiling joists and lath, caused the ceiling to flex and ultimately break the plaster keys, making it disengage and fall.

Physical evidence indicates that the ceiling was likely lathed/plastered for the first and only time during this period. The weight of the additional ceiling joists/lath/plaster, coupled with yearly snow load pressure on the rafters, caused the collar ties to sag and the ceiling to flex, thereby breaking the “keys” of the plaster, allowing the plaster to disengage and fall down.

*Looking up at the joists and lath of the ceiling, where the plaster has fallen away.*

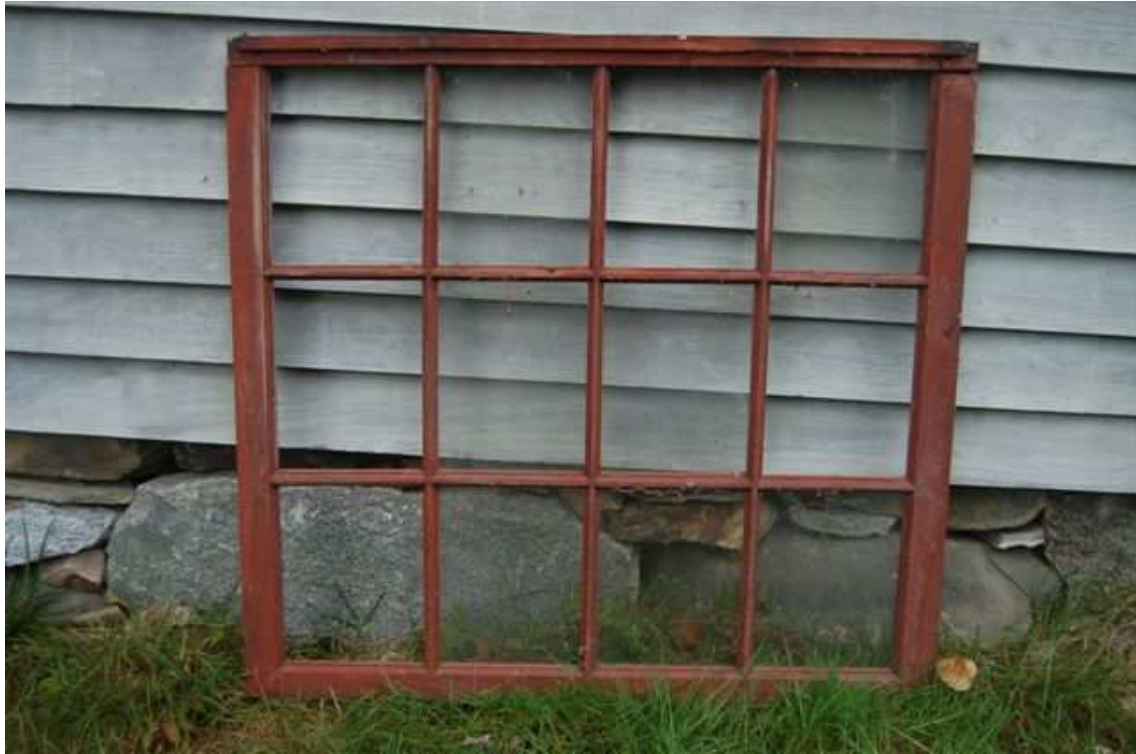
The exterior surfaces of the building (trim, windows, doors and clapboards) were replaced in the late 1980s with new materials. The replacement window units (frame and sash) are slightly smaller than the original openings. A window sash found in the building is probably a second generation sash (circa 1792), but could possibly date to the original construction of the building. This sash is important for two reasons. First, it helps define the sash configuration (twelve-over-twelve) and also the individual glass size (7" x 9"). Second, paint samples can help determine the color history of the exterior and/or interior of that sash. If the clapboards, windows and trim are removed in the future, additional paint analysis may be possible where paint may have adhered to the original sheathing boards.

*Historic window sash*

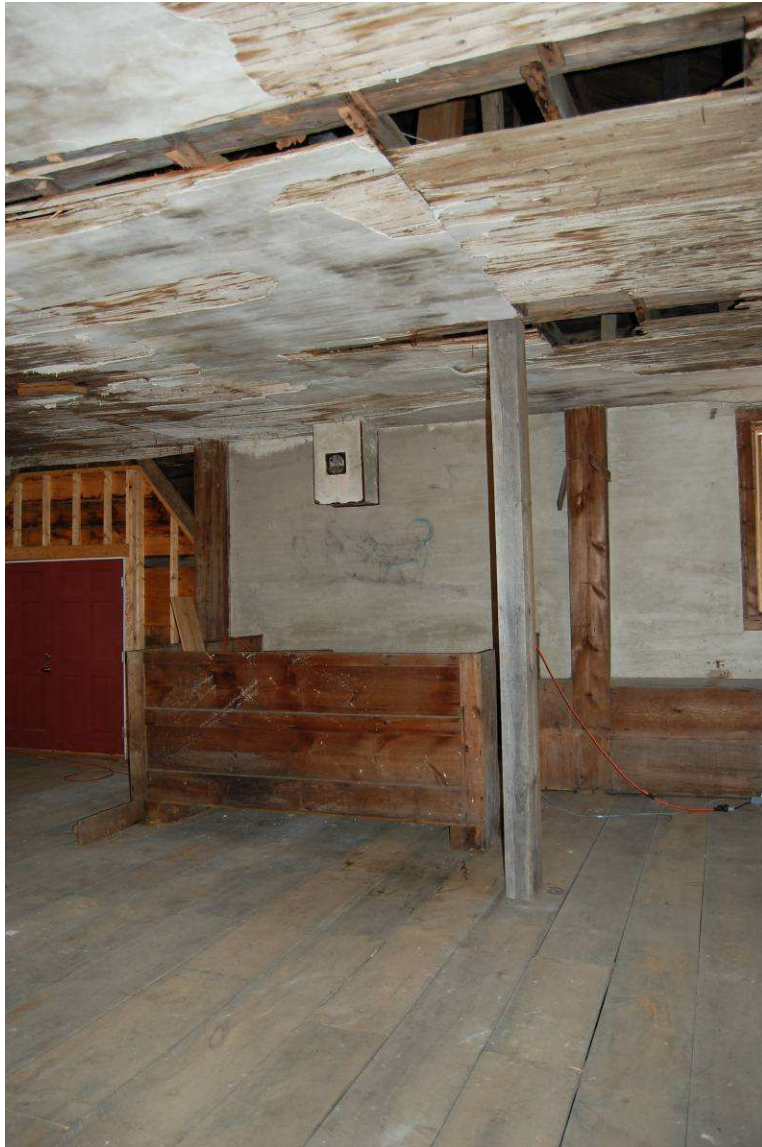
*Looking southwest toward the moderator's box. Note also the ceiling joists, seen where the plaster has disengaged. Remains of the stove chimney can be seen in the center of this image, above the moderator's box.*
