Merrymeeting Dams Investigation and Assessment

New Hampshire Department of Environmental Services

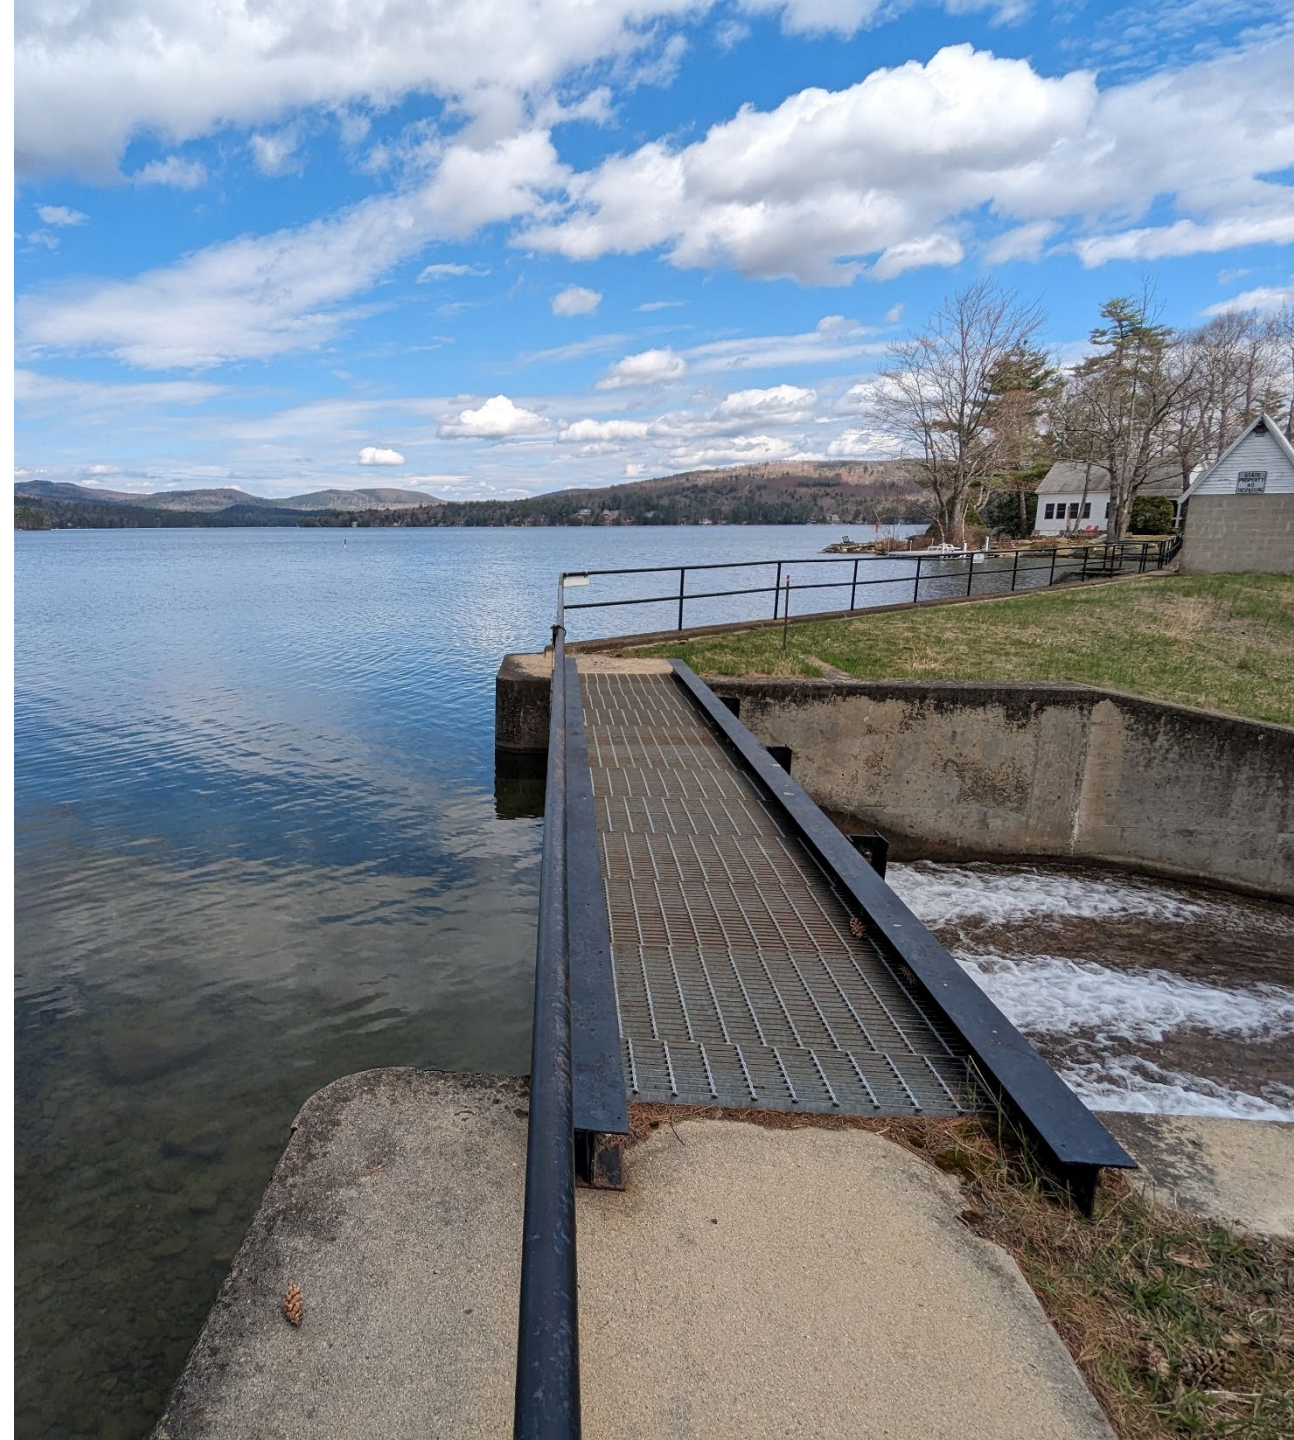
Merrymeeting Lake Dam

- Owner/Operator:
 - NH Fish and Game Department
- Hazard Classification: High
 - Classification relates to the downstream impact of failure.
- Condition Rating: Poor (2019)
- Total Length: 285 ft
 - Spillway Length: 22 ft
- Maximum Height: 22 ft
- Purpose: Recreation
- Constructed in 1924
 - Reconstructed in 1969, and 1983

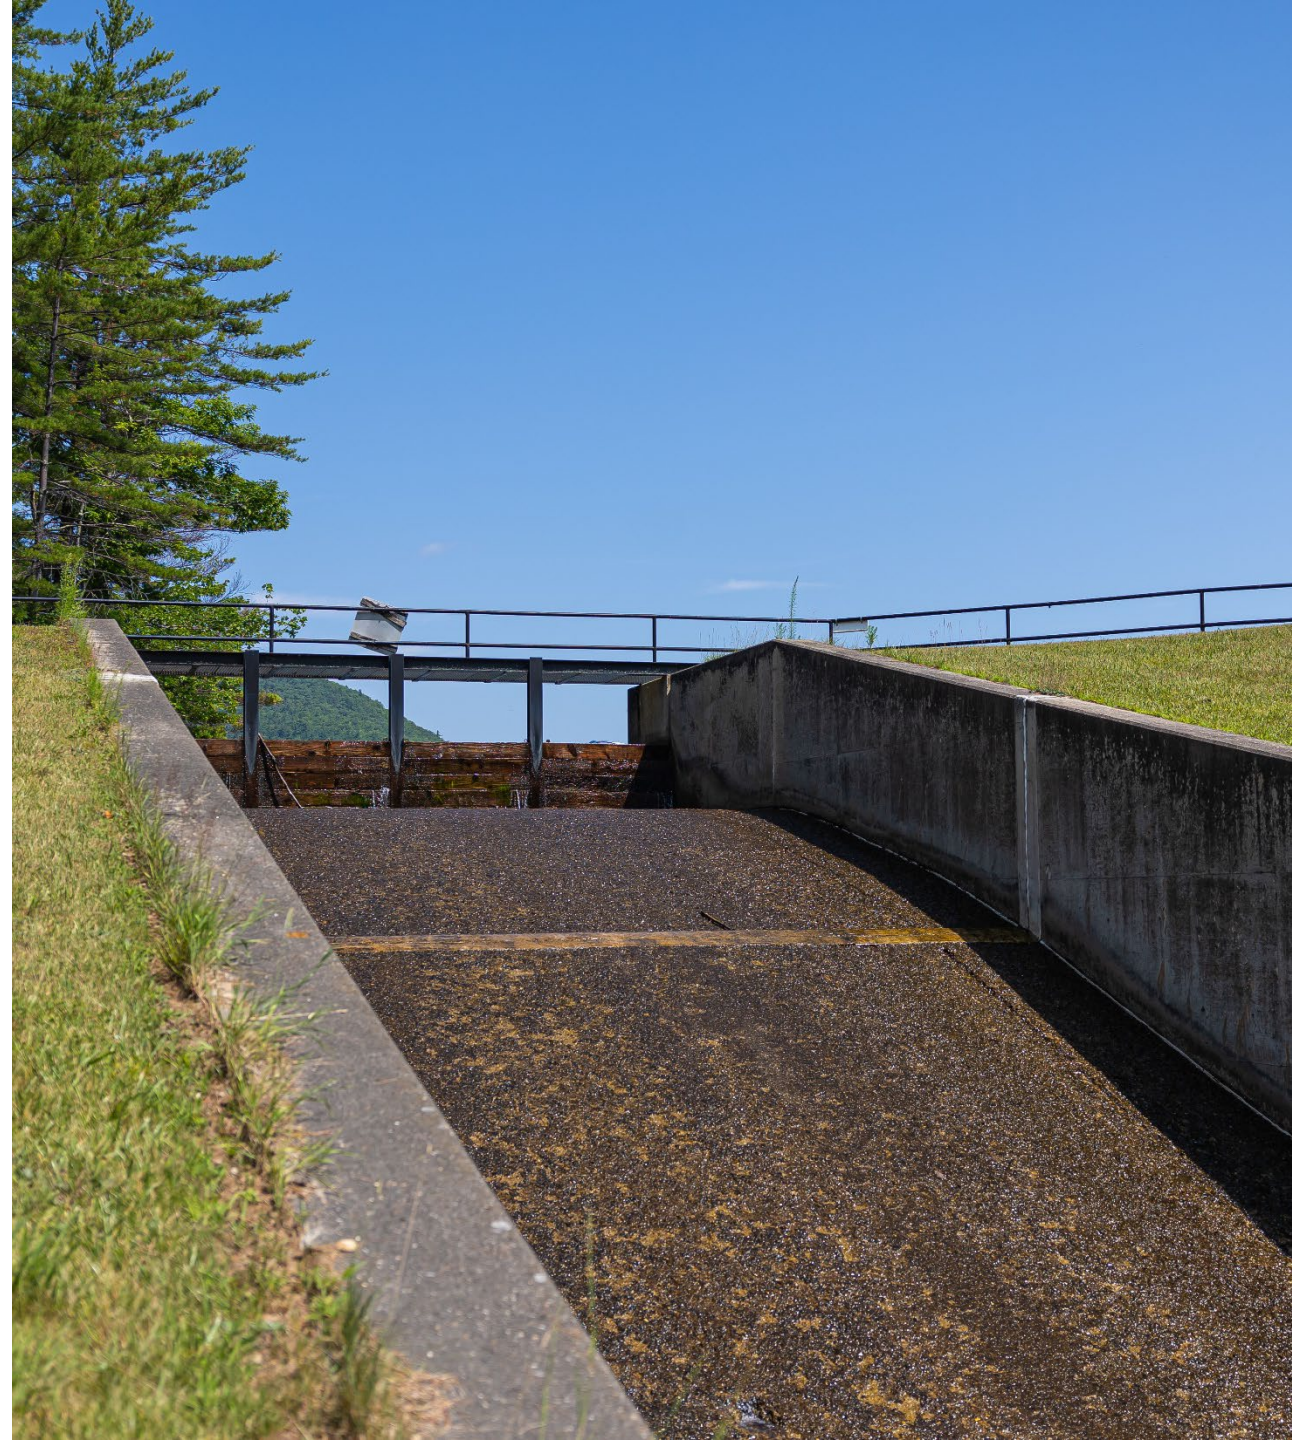
Jones Dam

- Owner/Operator:
 - NH Fish and Game Department
 - NHDES Dam Bureau
- Hazard Classification: High
- Condition: Poor (2021)
- Total Length: 210 ft
 - Spillway Length: 66 ft
- Maximum Height: 21 ft
- Purpose: Recreation
- Constructed in 1924
 - Reconstructed in 1986

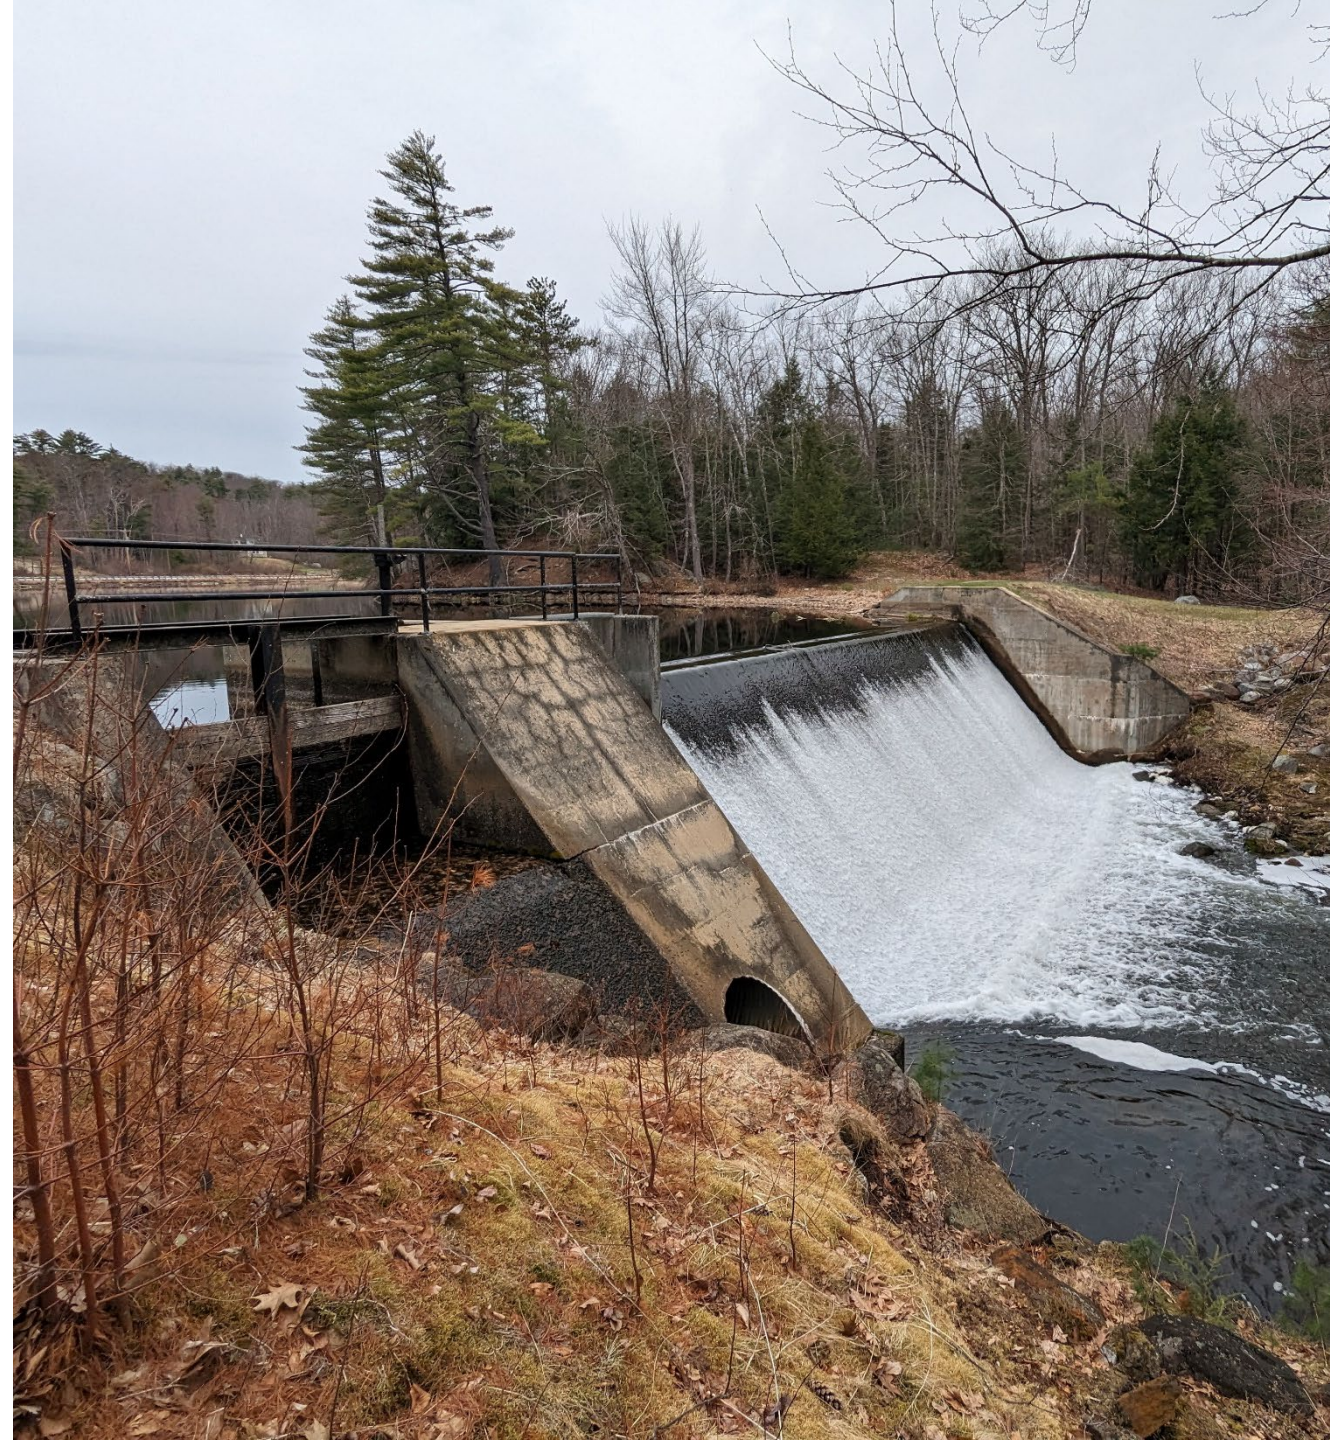
Alton Power Dam

- Owner/Operator:
 - NH Fish and Game Department
- Hazard Classification: High
- Condition: Poor (2018)
- Total Length: 190 ft
 - Spillway length: 80 ft
- Maximum Height: 16 ft
- Purpose: Recreation
- Constructed in 1923
 - Reconstructed in 1986
