APPENDIX A: THEMATIC WATERSHED MAPS

Merrymeeting River & Lake Watershed

New Durham, Strafford County, NH
Alton, Belknap County, NH

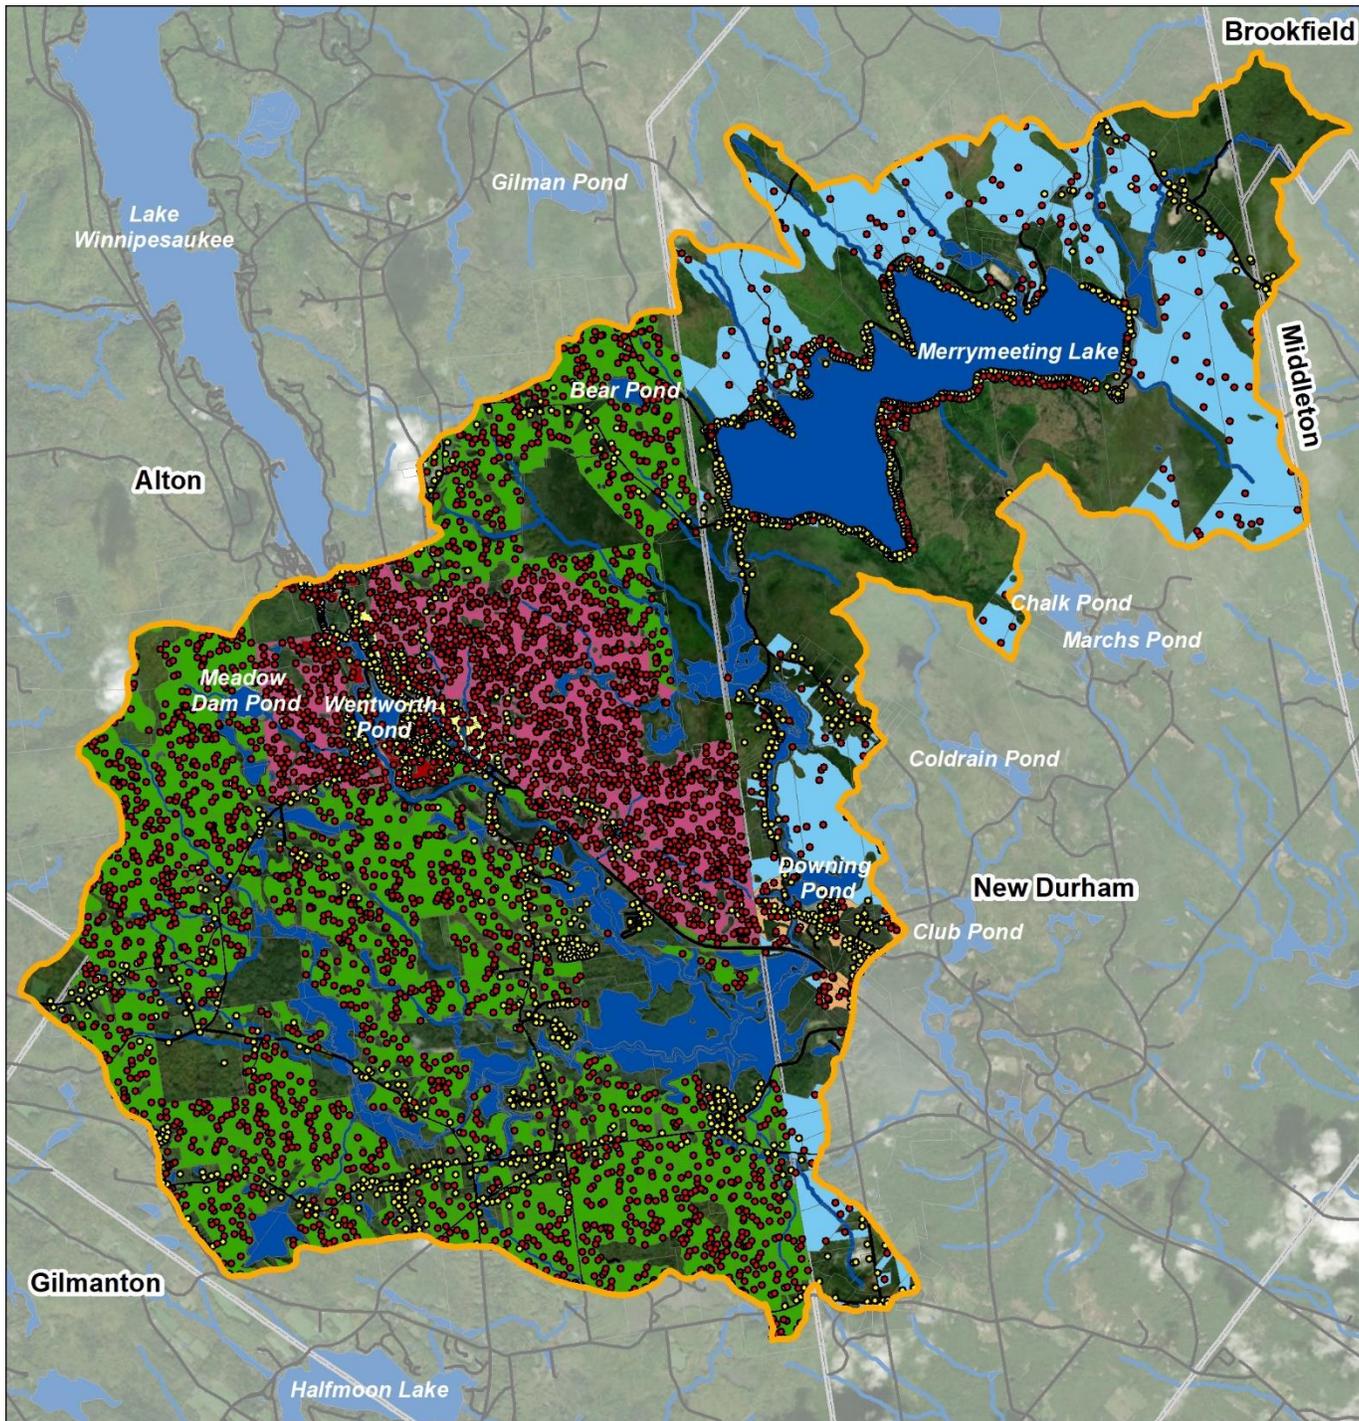
MAP 8

Buildable Area by Zone

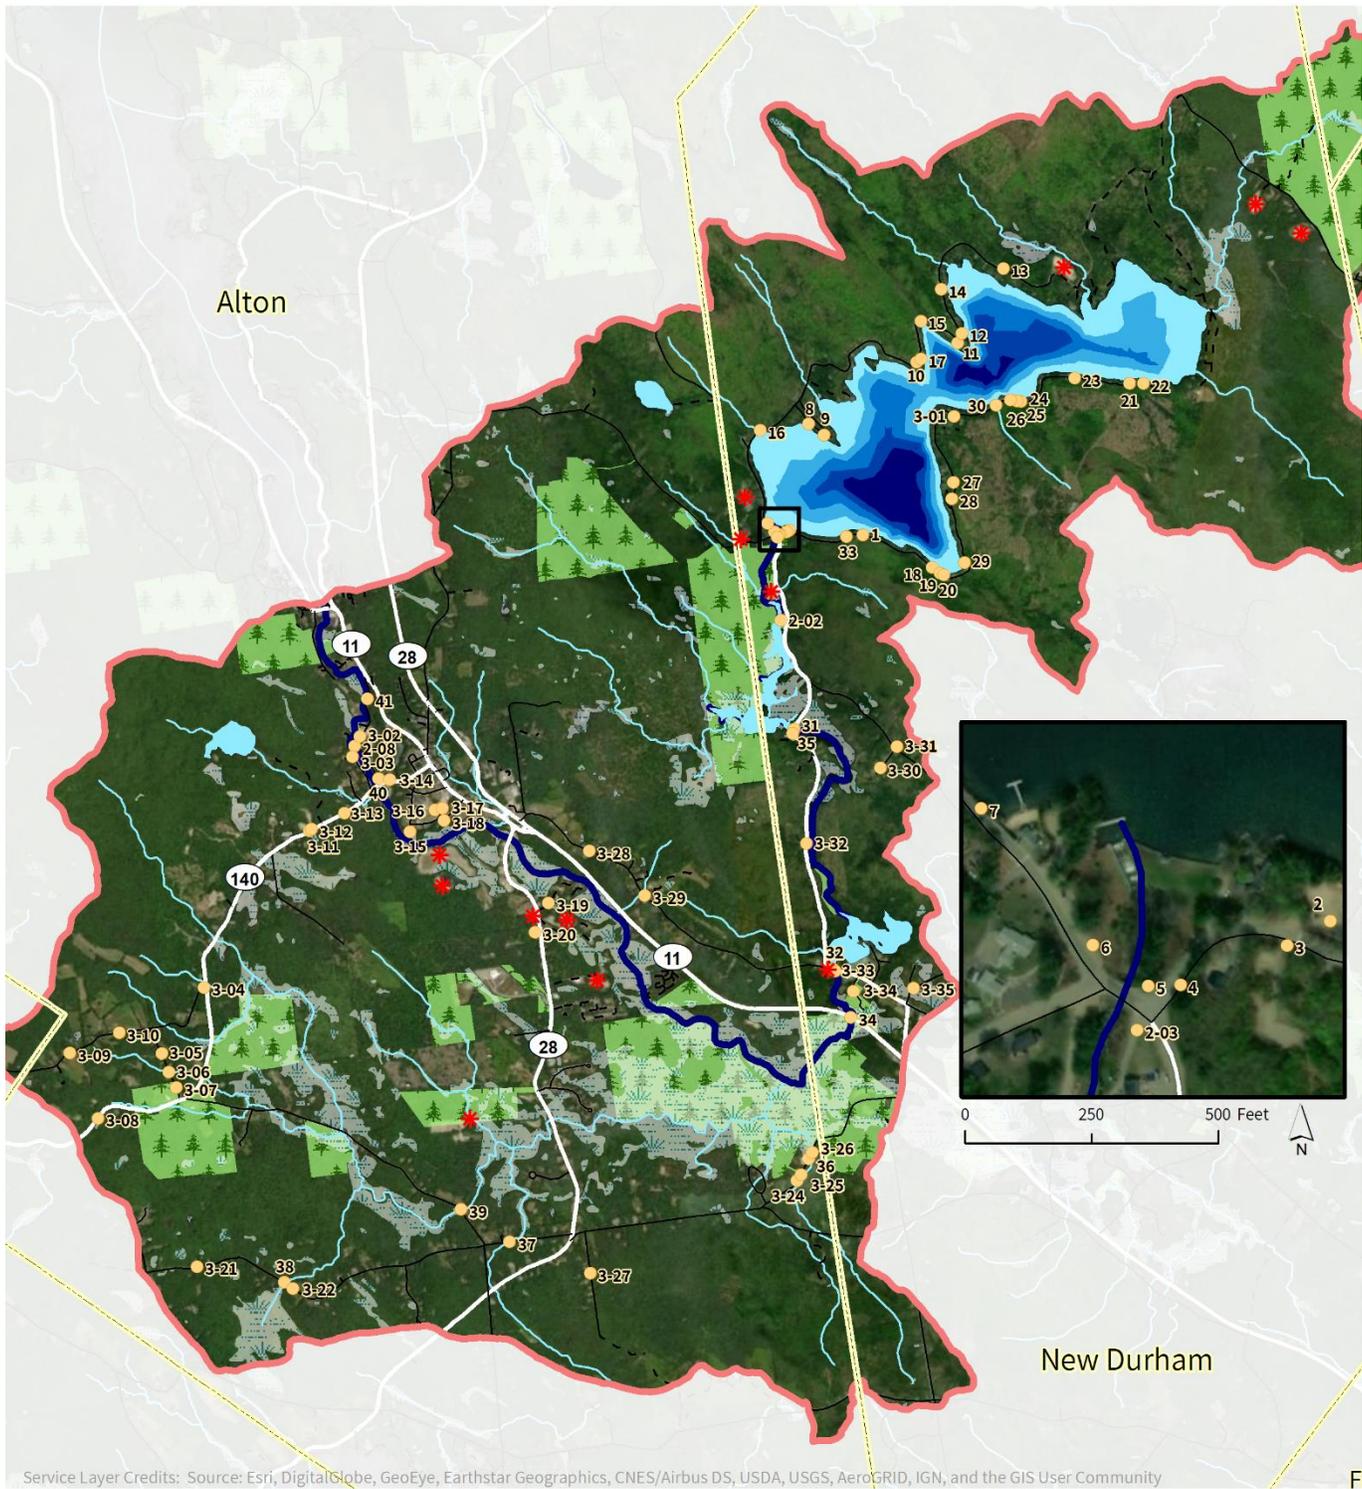
Merrymeeting River & Lake Watershed Survey Results
